Manhole Inspection Summary

Manhole # S29QQ_003MH

Insp Date: 8/4/08 2:13 PM

Location Address: 2800 FALLS RD

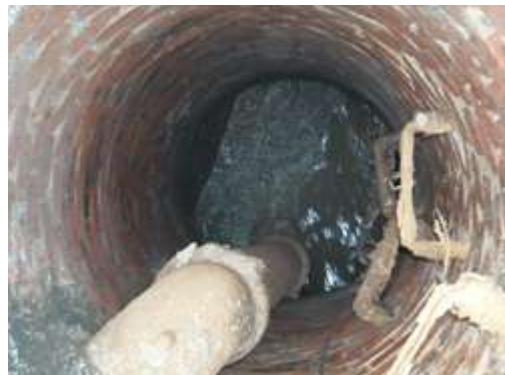
Top View

Corroded steps. Evidence of surcharge - Bench debris.

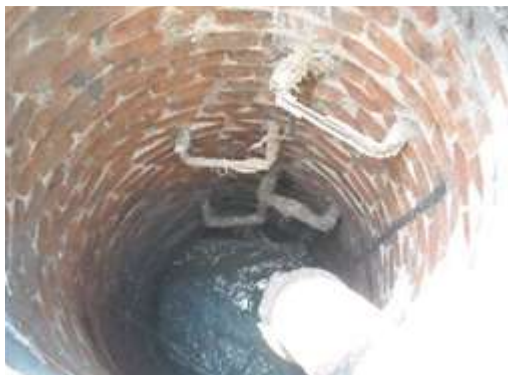
Defect

CORRODED STEPS

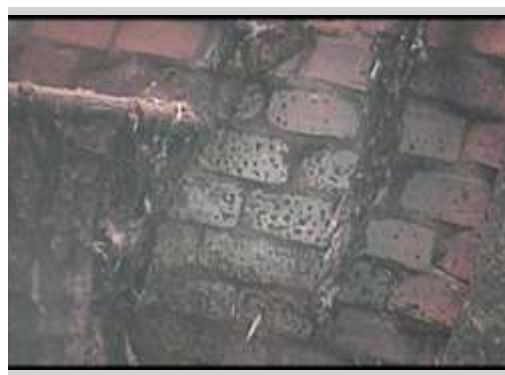
Defect

Corroded steps. Evidence of surcharge.

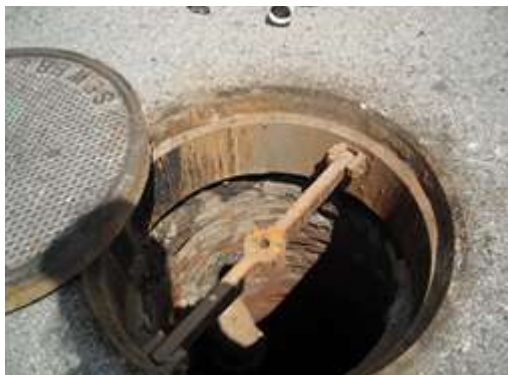
Defect

INFLOW EVIDENCE FROM SHEETING

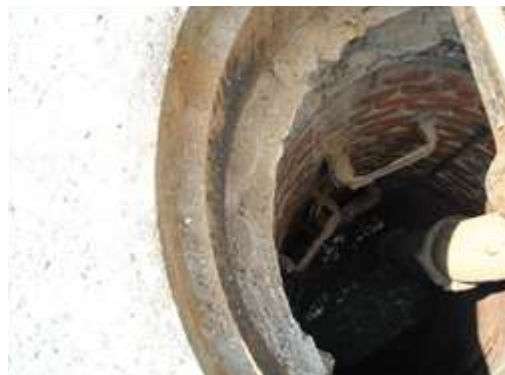
Defect

Offset: 2 (in.)

Frame offset.

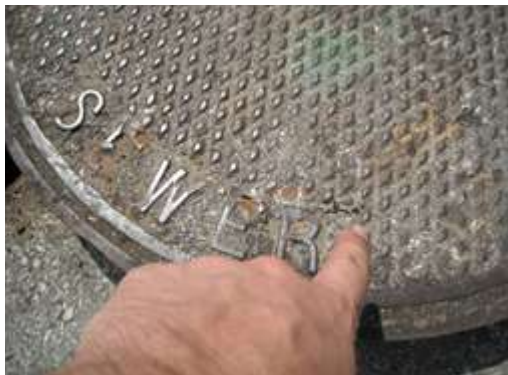
Defect

Condition: Cracked

Cracked cover.

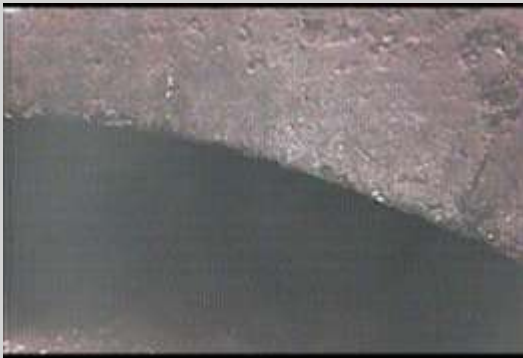
27 in. Circular Gravity Sewer Pipe Out @ 12 O'Clock

LOCKING COVER; UNABLE TO OBTAIN A SINGLE PIPESEAL SHOT ON 12 O'CLOCK PIPE; UNABLE TO OBTAIN INSIDE PIPE MEASUREMENT, DOES NOT APPEAR TO BE A DROP CONNECTED TO 7 O'CLOCK

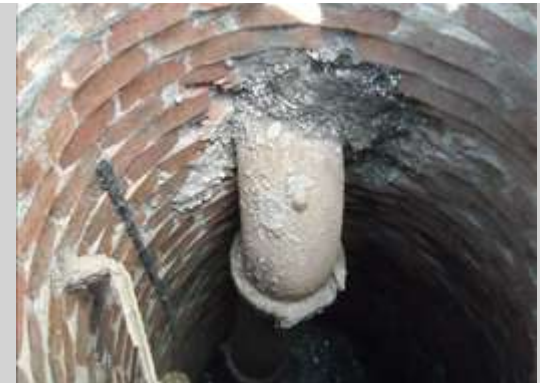
Pipe In @ 8 O'Clock

POSSIBLE HOUSE/SEVICE LINE ABOVE 7 O'CLOCK; PIPE IS APPOX. 8 INCHES

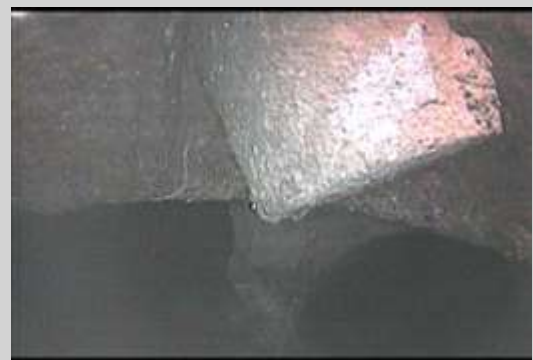
Drop In @ 8 O'Clock

LOWER END OF INSIDE PIPE; NO FLOW LEVEL WITH TOP OF 6 AND 12 O'CLOCK PIPES

Infiltration: **Evidence**
